Customer Name Trim Pal California Customer Type Patient  
 Company Name \_\_\_\_\_ Contact Name \_\_\_\_\_  
 Phone Number \_\_\_\_\_ Email Address \_\_\_\_\_  
 Strain Name Sour OG Before Sample Type Flower

**Potency Analysis Results**

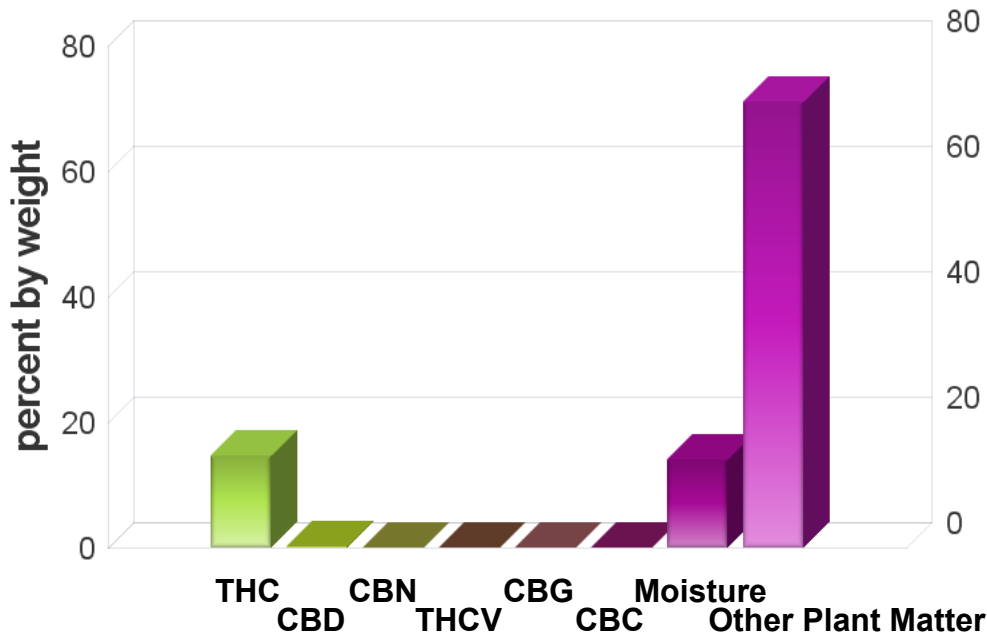
<b>THC</b> 14.70%	<b>CBD</b> 0.18%	<b>CBN</b> 0.03%	<b>THCV</b> 0.04%
<b>THCA Est.</b> 15.97%	<b>CBG</b> 0.01%	<b>CBC</b> 0.01%	<b>THCVA Est.</b> 0.04%

**Cannabinoid Concentrations**

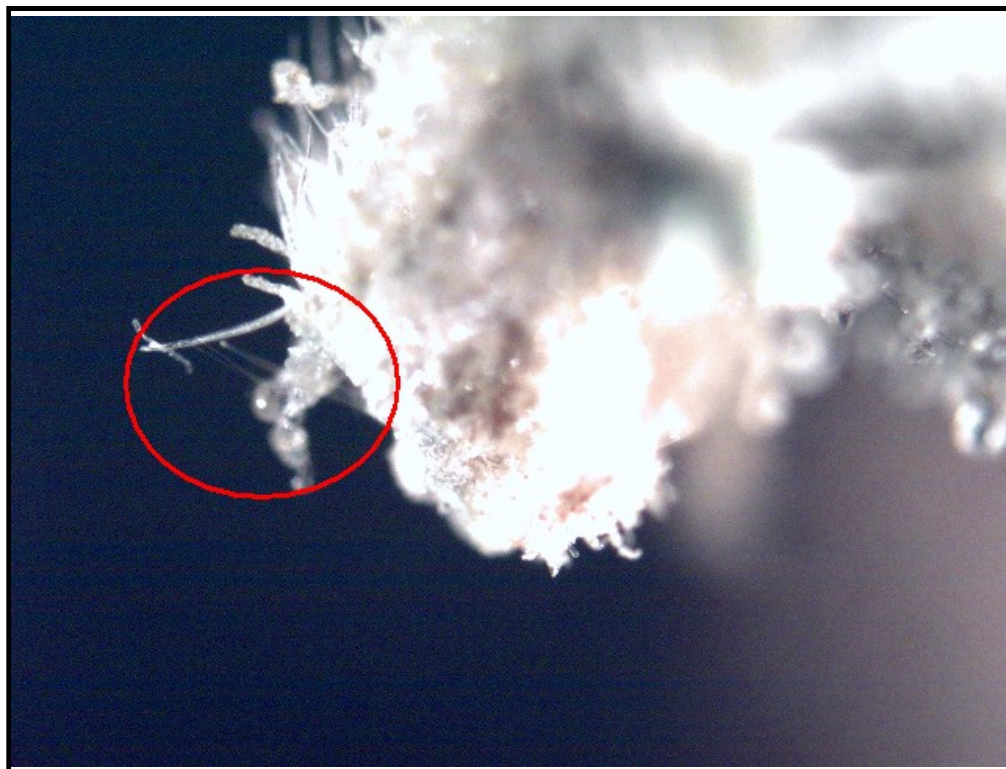
Colonies of Mold	Not Found
Particulates	Not Found
Insect Activity	Not Found
Other	Not Found

40 x Magnification
